# NGK SPARK PLUG NEWS

PNT 2016-012-SP-Installation Damages  
Date 02.05.2016

## Fitment Damages ZKBR7A-HTU

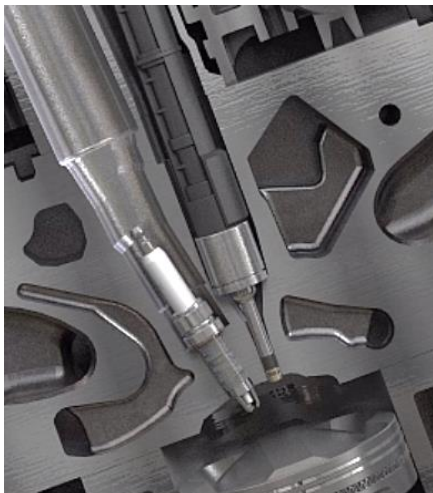
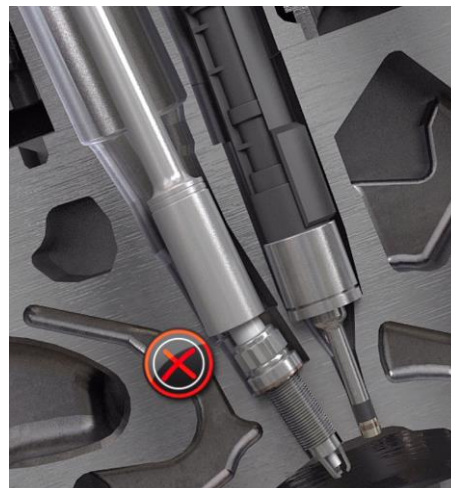
The affected spark plugs are all installed in BMW Engines, Code N43 and N53. In these engines, the spark plug is installed in the shaft with an angle of more than 5°. Therefore, the spark plugs must be removed/ installed with a special socket with articulated joint. The standard socket cannot be used!

To avoid the damages and misfiring, it is mandatory to use a special spark plug socket with articulated joint. These tools are available at special tool manufacturers. (Note: A bix- hex version is needed!)

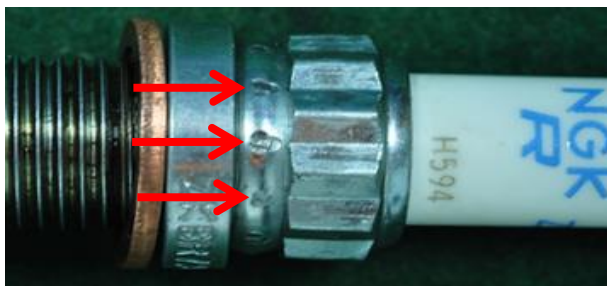
The installation position cannot be seen by looking into the shaft from the top. Mechanics therefore try to use the normal spark plug socket, and fit it to the plugs with force (by hammering it to the plug). Traces on the damaged plugs proof this. Since the Plugs are installed in an angle, the socket creates a side pressure to the insulator of the plug, which causes the cracks.

*Traces of a spark plug socket that was hammered - in with force*

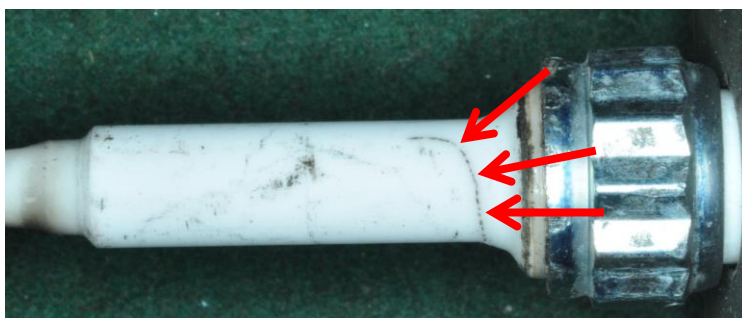
After disassembling the spark plugs, we detected cracks in the insulator portion. These cracks allow the spark to pass through the insulator, causing misfire. The cracks in the insulator portion were caused by mechanical impact against the side of the insulator. Visual inspections also showed that the affected plugs show traces which are caused by forced application of the spark plug socket.

*(disassembled spark plug- thread removed)  
Crack in the insulator portion, causing spark-through*
